# RESTORING FIRE DETECTION CONFIDENCE

*The use of visual flame detection equipment can provide operators with a proven and comprehensive early warning system*

Micropack were contracted by a major oil company to perform a flame detection mapping review on a number of floating roof crude oil storage tanks on one of their refineries in the UK.

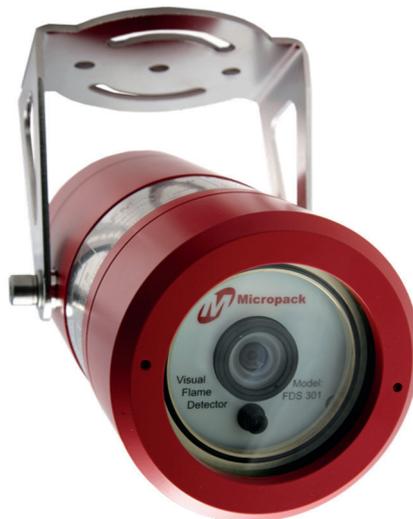
**Micropack FDS301 visual flame detector**

The client wished to resolve the false alarm issues by utilising visual flame detection as a primary means of detecting fires at the rim seals. Visual flame detectors were proposed to be mounted in fixed locations at the top rim of each tank to view the circumference of the floating roofs without the need to run an umbilical to the roof itself. This resulted in no moving power connections required to accommodate the mobility of the floating roofs.

The visual flame detector also includes a live video feed of the detectors field of view, which means that the area can be monitored

from the control room and in the event of a fire, personnel do not have to venture into a potentially dangerous situation. Following an alarm or incident, recorded video footage from before, during and after the alarm signal is generated which can be reviewed to gather information on the event retrospectively. This information is invaluable to the incident investigation team to ensure lessons are learned from any fire.
